SR 3 MP 58.21 Unnamed Tributary to Hood Canal (991240): Preliminary Hydraulic Design Report

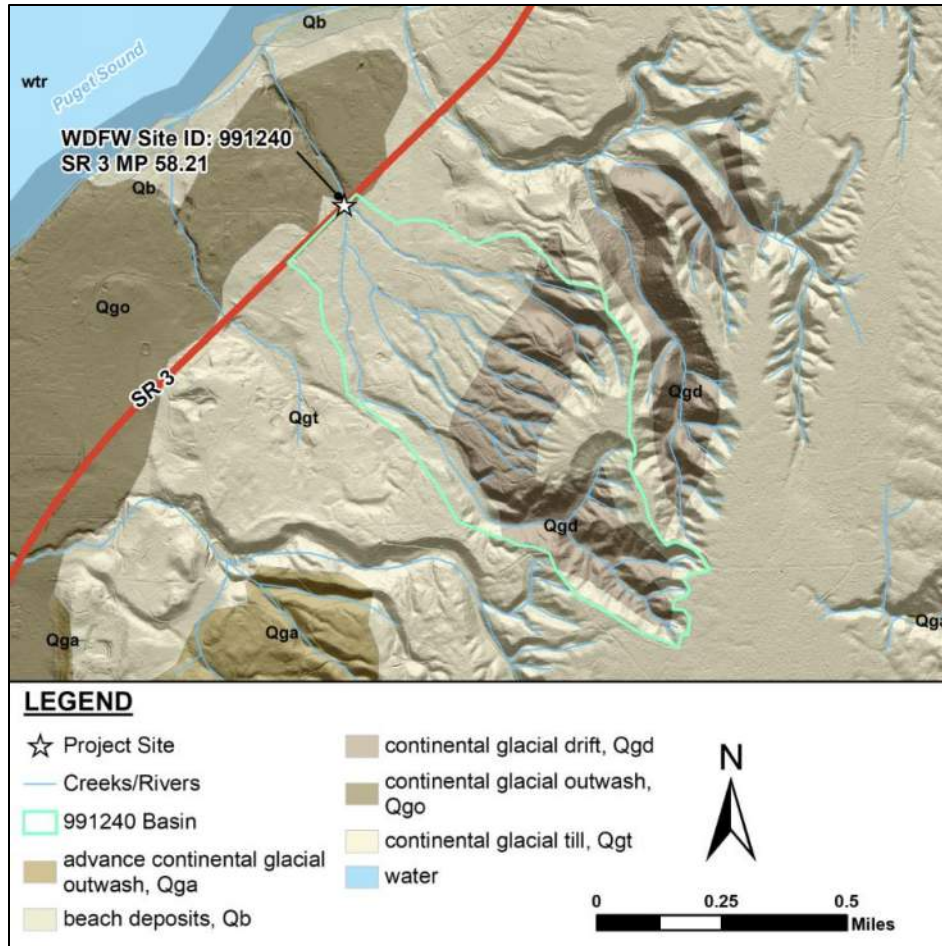
Figure 4. Geologic map

Qgt (continental glacial till) underlies the north side of the Kitsap Peninsula within the project vicinity (DNR, 2010). The till deposits are found on hills, ridges, slopes, and valley sides, either as the topmost unit or beneath younger outwash deposits. Till consists of a non-sorted mixture of mud, sand, pebbles, cobbles, and boulders. The till deposit is generally compact and often is referred to as hardpan, which has high resistance to surface erosion and landslide. The Port Gamble area consists of a till-underlain terrace with drift and outwash deposits mostly near the shoreline (Figure 4).

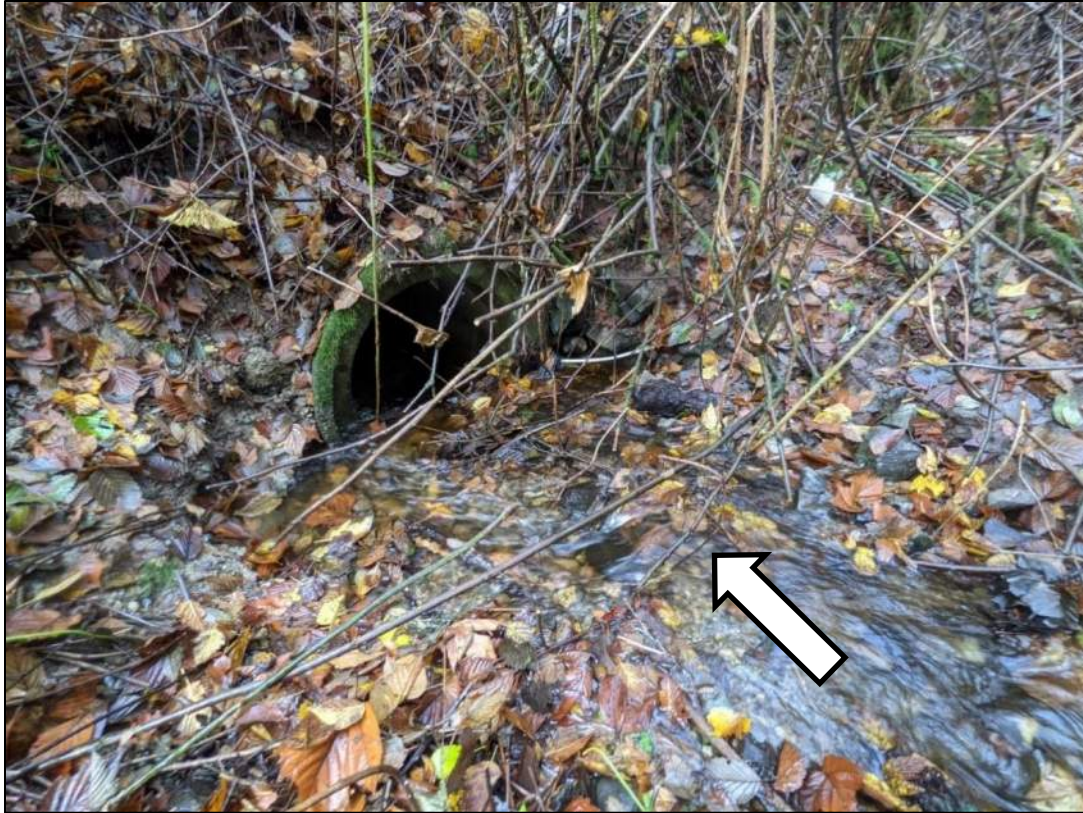
Figure 8. Culvert inlet

The crossing inlet is covered by dense brush and is partially filled with organic debris and sediment (Figure 8). Upstream of the crossing, the stream channel is approximately 5 to 10 feet wide and there is a floodplain bench approximately 1 to 2 feet above the stream channel for the majority of the surveyed reach. The floodplain is in a confined valley (Figure 10). See Section 6.1 for additional floodplain information. The wetted width on December 2 was approximately 5 feet, although it appeared recent higher flows had been much wider and spilled out onto the floodplain in areas. Surrounding the inlet and extending from the top of the roadway prism to approximately EX STA 15+00 is a dense thicket of vegetation that crowds around the channel (Figure 9). The east tributary joins the main channel in this thicket of vegetation and creates a mudflat. The main channel banks gently slope upward and transition into the surrounding floodplain.

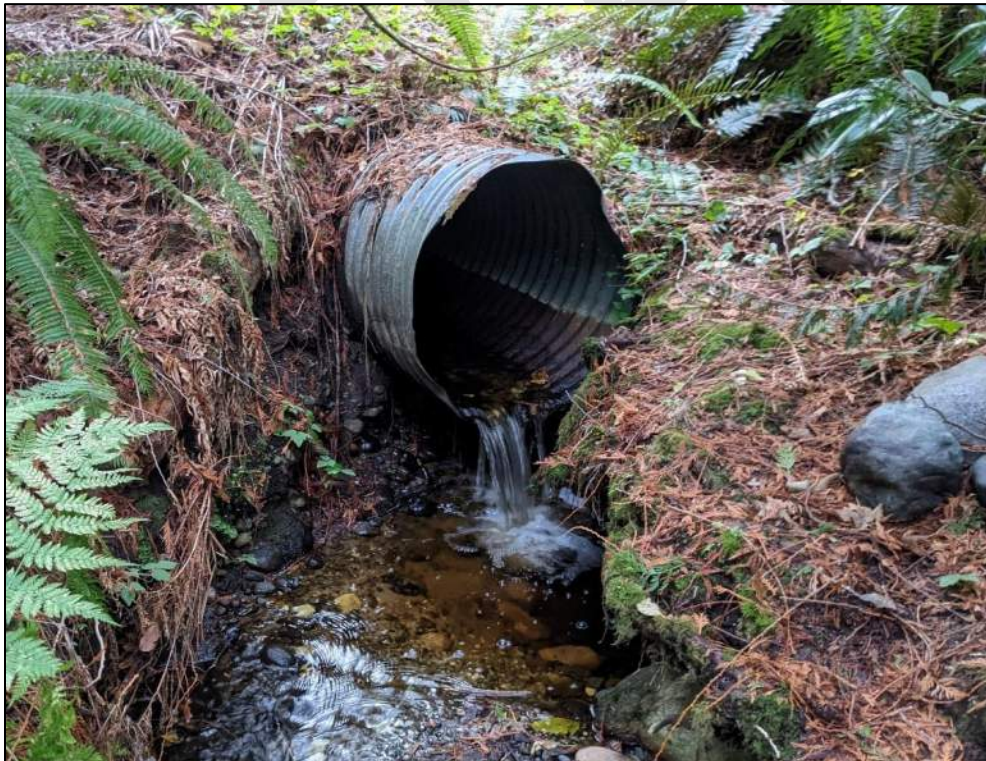
Figure 13. Outlet of driveway culvert

A driveway culvert is present approximately 355 feet upstream of the project crossing with the inlet at EX STA 17+85. The culvert was not listed in the WDFW fish passage database (WDFW, 2019). WSDOT survey found the 3-foot-diameter culvert to be 30.0 feet long and have a slope of 1.8 percent (Figure 13).

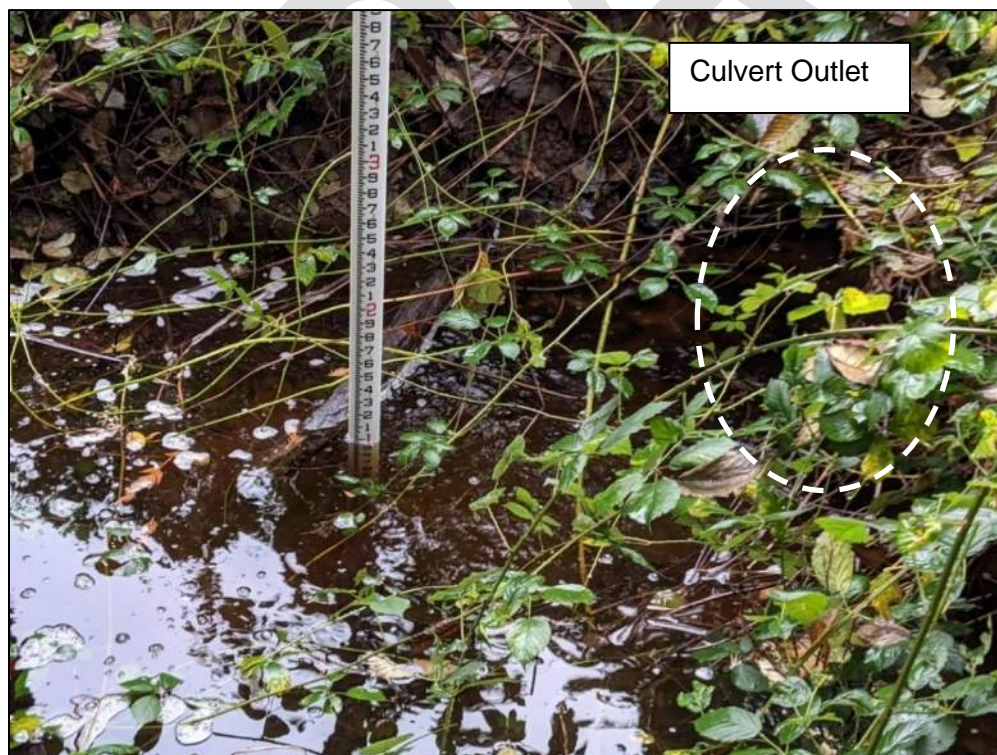
Figure 14. Culvert outlet at site visit 2

The existing project culvert is a 99.2-foot-long, 2-foot-diameter, round concrete culvert. The WDFW fish passage database shows that the crossing has a 4.0-percent slope and states that slope is the reason this structure is a barrier to fish (WDFW, 2019). However, WSDOT survey crews found the slope to be 5.1 percent (Figure 42). The project culvert alignment is approximately 20 degrees from perpendicular to SR 3. During site visit 2 the culvert outlet was overgrown with vegetation and there was a 1-foot-deep pool (Figure 14). At the time of site visit 3, the vegetation had been cleared away (Figure 15).

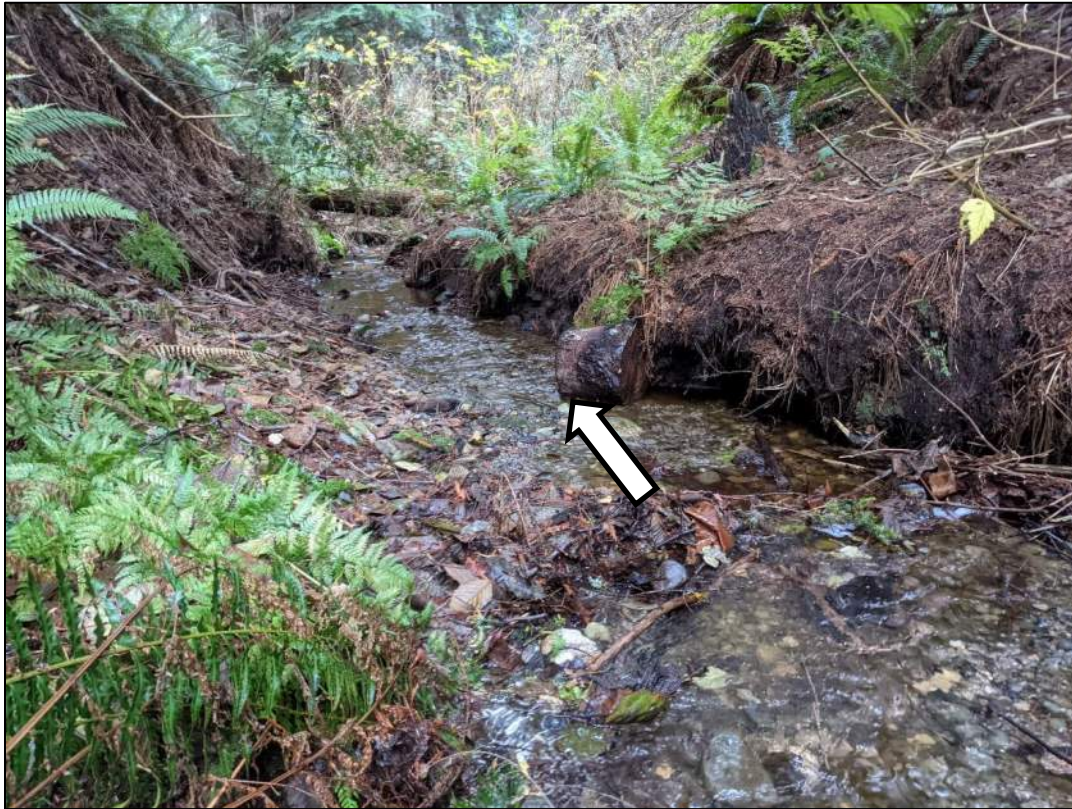
Figure 19. Steep undercut bank

At approximately EX STA 12+40 the channel widens slightly and the vegetation on the bank transitions from blackberry to salmonberry and dogwood. The channel in this reach appears to have recently undergone 0.5 to 2 feet of incision. At approximately EX STA 10+90 the right bank of the channel is undercut (Figure 19). The rounded break in slope forming the top of bank indicates any incision here is older or slower than the incision upstream. There was also glacial till observed in this section of the downstream reach. Cut pieces of wood were observed in the channel, which confirms the property manager account of cutting wood in the channel. Approximately 350 feet downstream of the crossing (near the property boundary) a large downed tree was observed in the channel, with other small pieces of wood racking near the larger log (Figure 6).

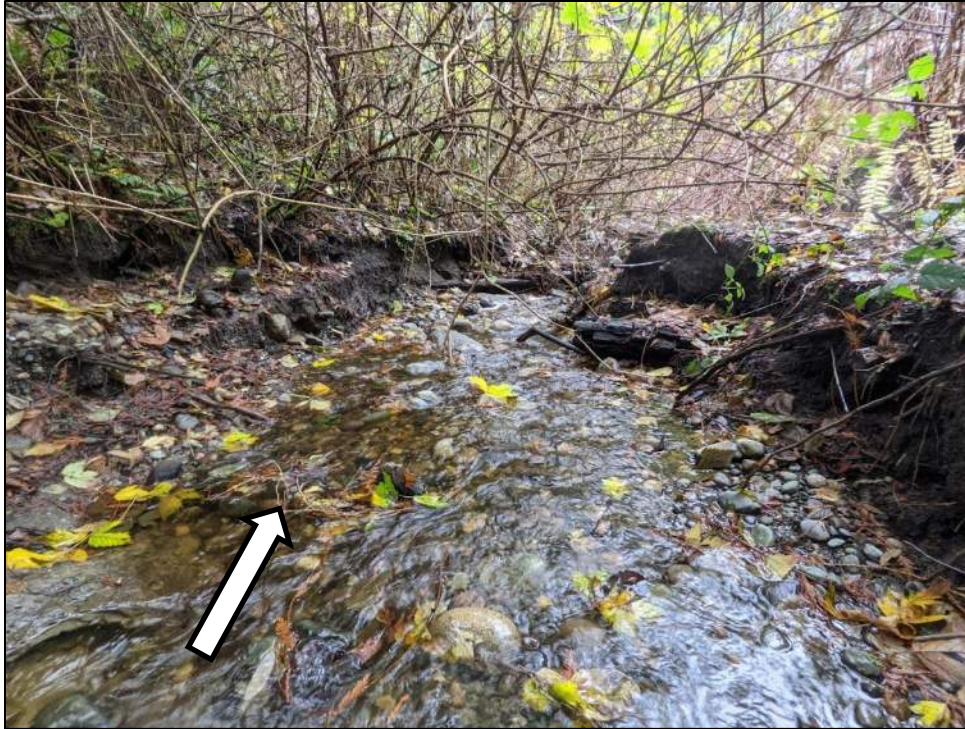
Figure 27. Vertical banks with no established vegetation indicating active incision in the downstream reach, looking downstream

Vegetation in the downstream reach is virtually identical to that in the upstream reach. During site visit 2 it was discovered that the landowner of the downstream reach had removed LWM on several occasions to avoid potential flooding. As a result, no large logs were observed within 250 feet of the culvert outlet. Farther downstream (EX STA 10+00) LWM was observed adjacent to the stream (Figure 26). Channel banks are either nearly vertical or undercut throughout the vast majority of the downstream reach (Figure 27).

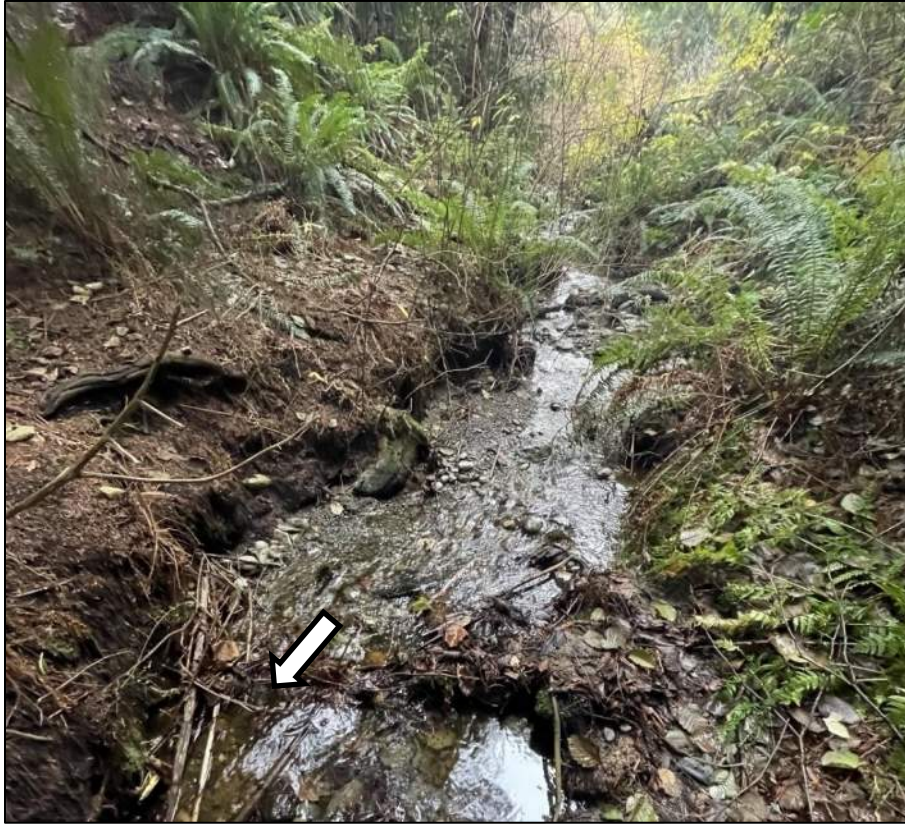
Figure 29. Downstream design reach looking upstream

The crossing lies at a transition in slope with the downstream design reach slope of 4.6 percent, and the upstream design reach slope of 3.4 percent (see Section 2.7.4). To provide a smoother and more natural tie-in, the slope from the downstream design reach was used to inform the design slope. BFW measurements were taken from the downstream design reach after the east tributary combined with the main channel (Figure 29).

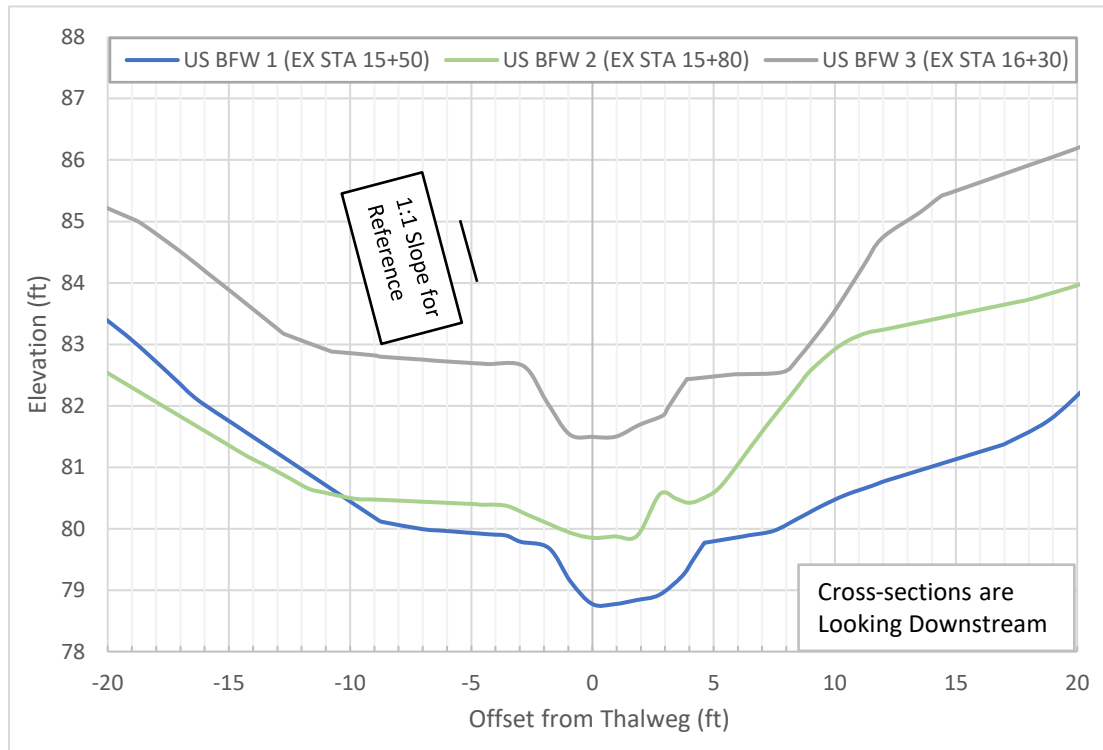
Figure 31. Existing cross-section examples

The width to depth ratio, defined as the BFW divided by bankfull depth, is 6.8 at US BFW #1. The bankfull width was 6.1 feet and the bankfull depth was 0.9 feet. This location was used to inform the design channel shape which has a width-to-depth ratio of 6.4. Existing channel dimensions were based on site observations and measurements. The recent incision seen downstream is evidence the stream is in Stage III of the channel evolution model (Simon & Rinaldi, 2006).

channel shape just downstream at approximately EX STA 15+50 (Figure 31) with the understanding that upstream BFW measurements would not be used to size the MHO.

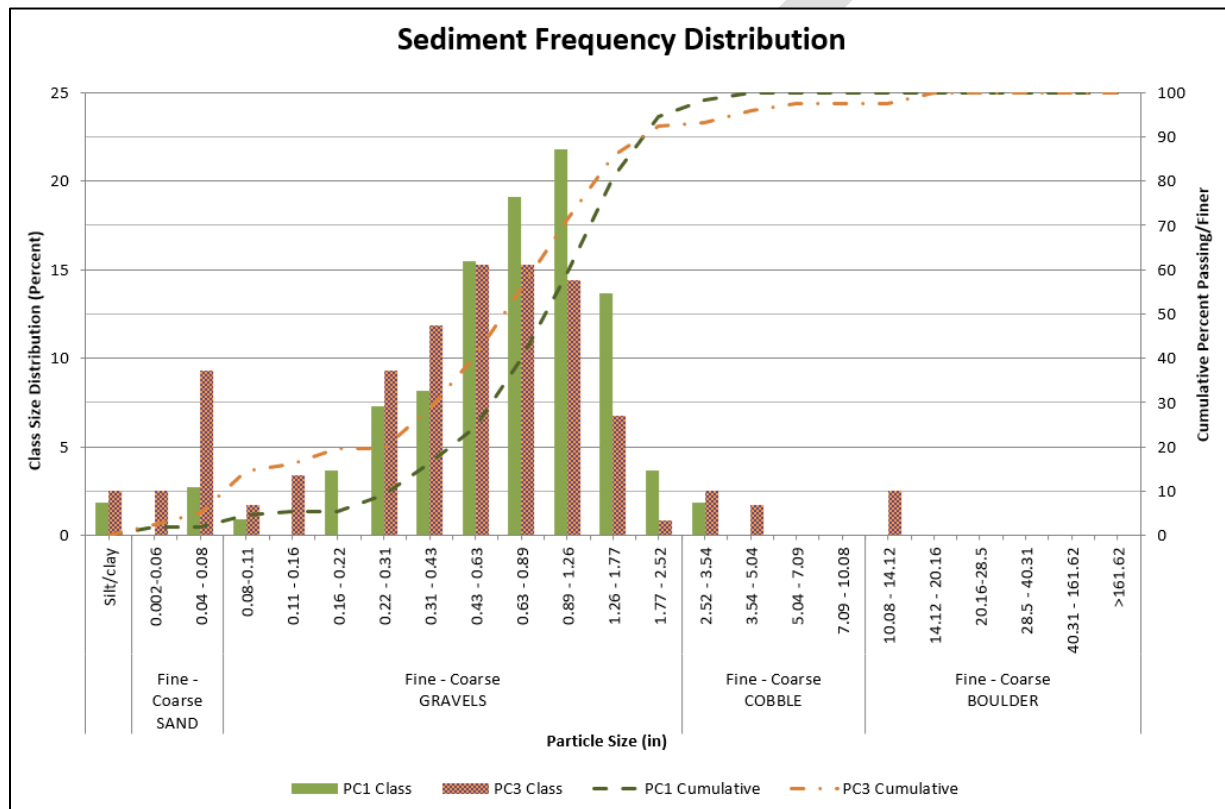
Figure 33. Sediment size distribution

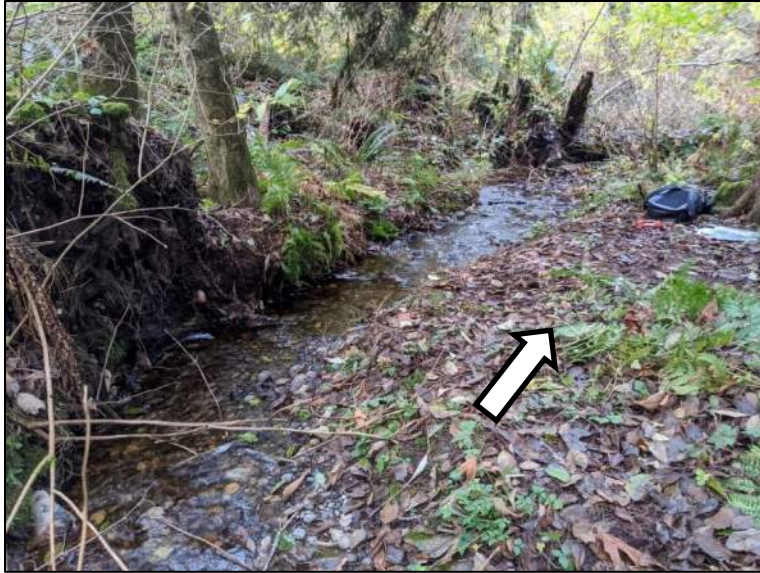
Figure 34. Pebble count #1 location

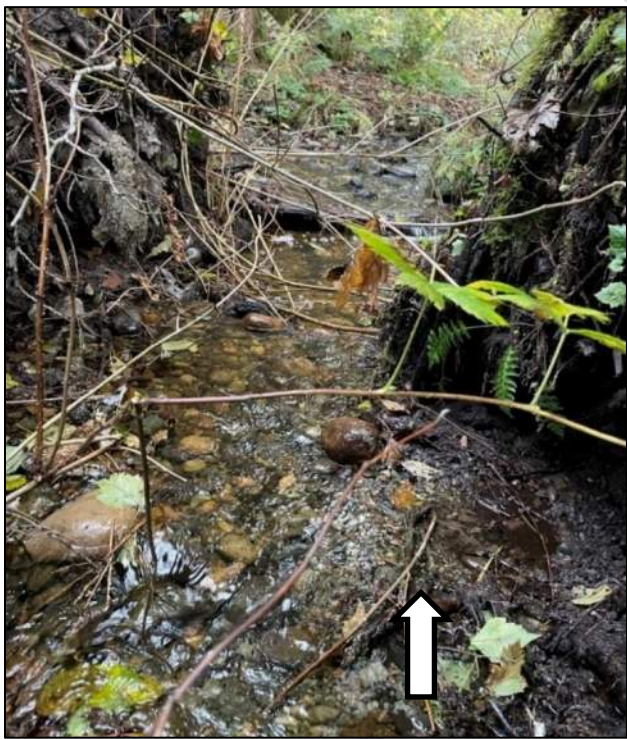
Figure 35. Closeup of sediment near pebble count #1

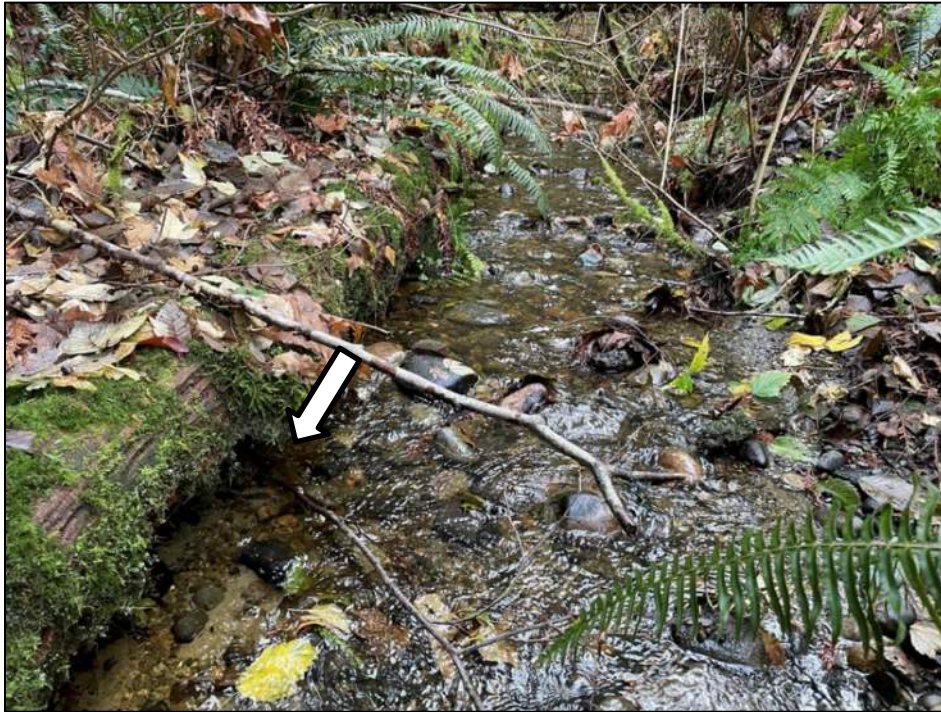
Figure 36. Close up of sediment at upstream pebble count #2

Pebble count #2 was taken at the same location as US BFW #2 at EX STA 15+80 (Figure 36, Figure 37) At this location, the right bank was formed by a log parallel to the flow and the left bank was not clearly defined, with groundwater seepage creating a wide muddy bench. At site visit 3, it was decided by comanagers that US BFW #2 should not be included in the average BFW calculation because that area had an unusually wide and saturated groundwater intrusion area; therefore, it was also deemed not suitable to include in the average pebble count data because sediment from this region is not representative of the stream's natural state.

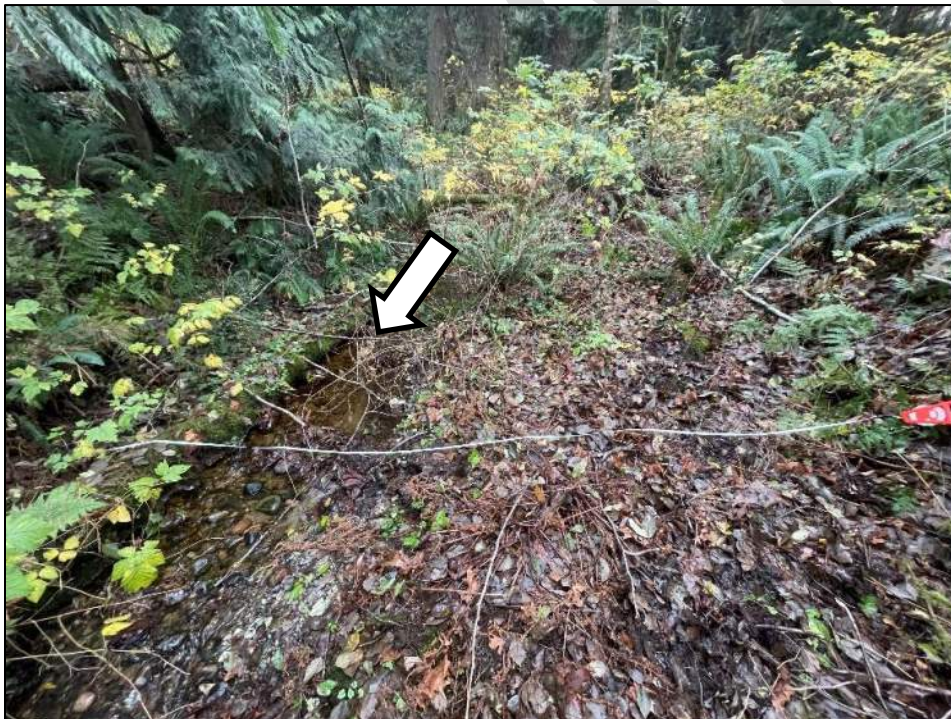
Figure 37. Log forming right bank at US BFW #2 and pebble count #2

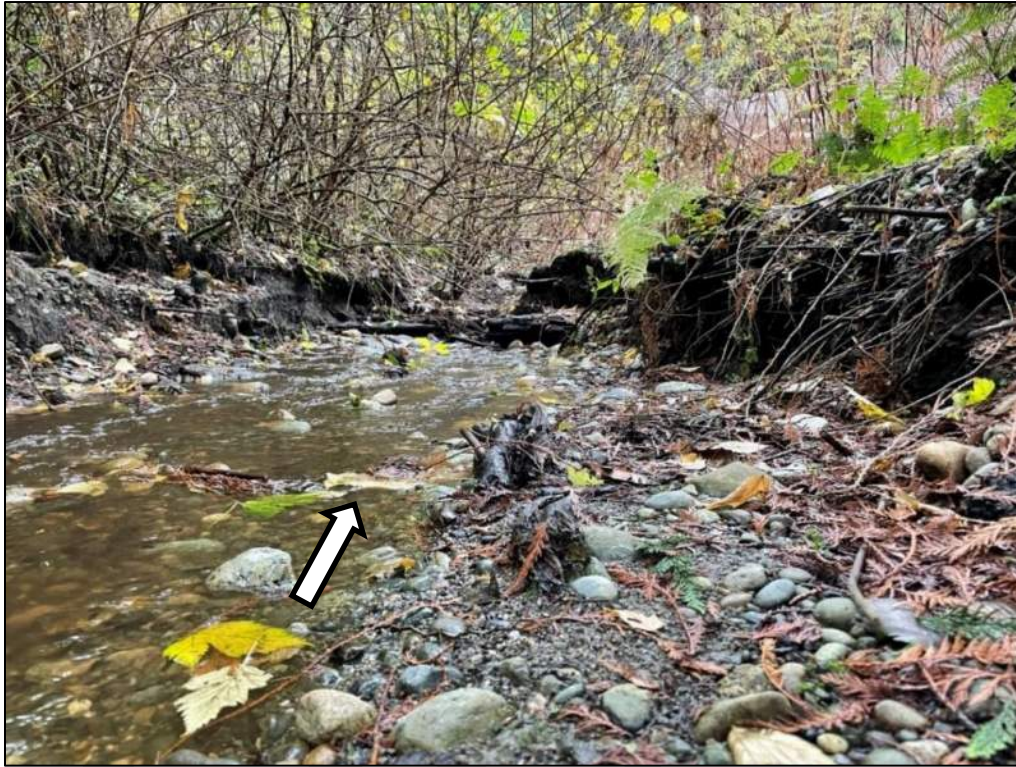
Figure 38. Close up of the sediment at pebble count #3

There were several large, stable boulders observed in the downstream design reach ranging from about 12 inches in diameter (Figure 39) to a single large lag deposit boulder over 2.5 feet in diameter (Figure 40) forcing a significant meander in the stream. Pebble count #3 was taken at DS BFW #1 at EX STA 12+02. The stream consisted of a riffle at this location with steep banks on both sides. The majority of sediment sampled at this location was coarse gravel with fines appearing with greater frequency as the count approached the banks (Figure 38). However, there was also a significant amount of both fines (mainly sands), along with scattered cobbles and boulders.

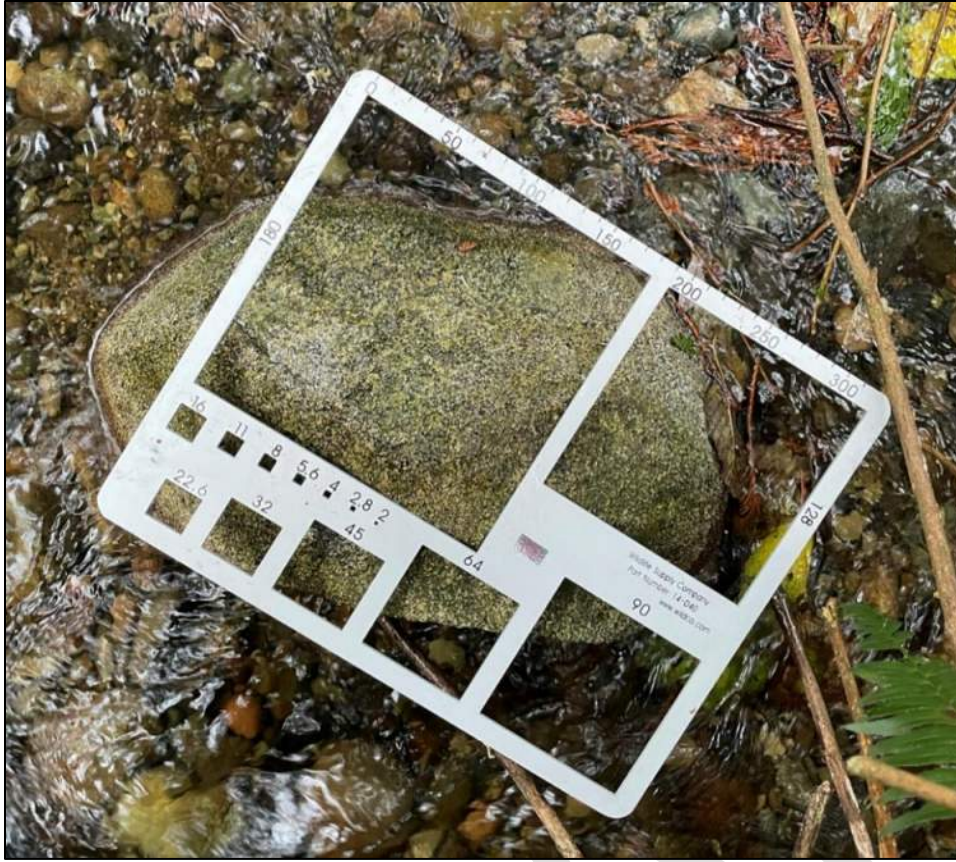
Figure 39. Smaller boulder around DS BFW #4b

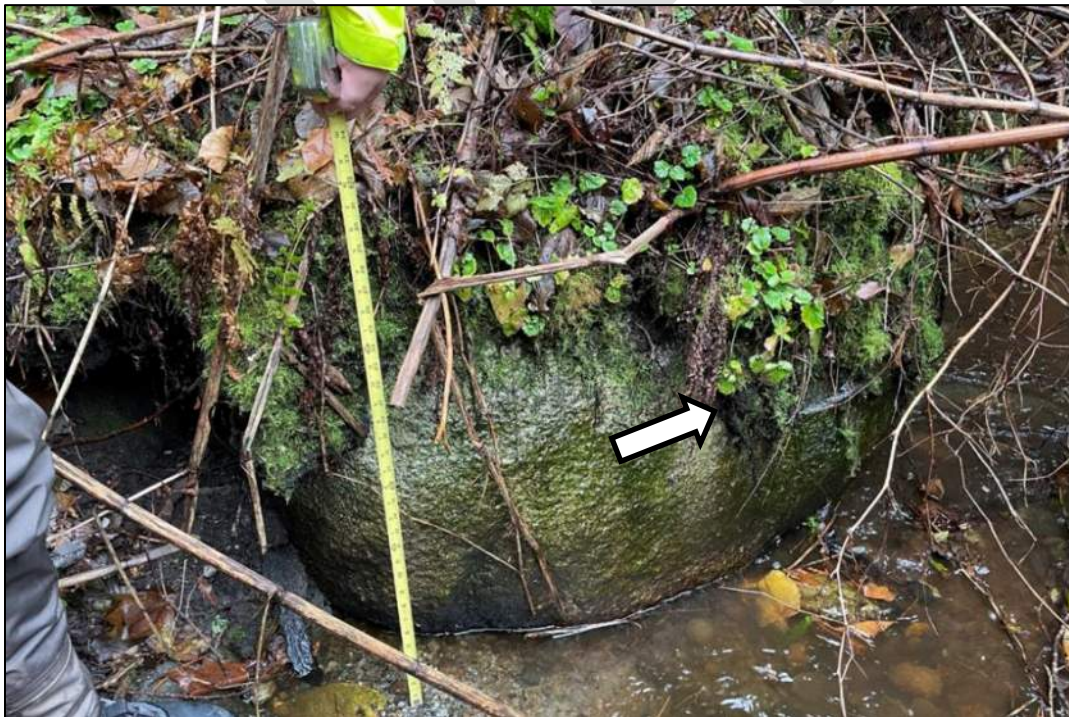
Figure 40. Large boulder protruding from the bank about 200 feet downstream of the culvert

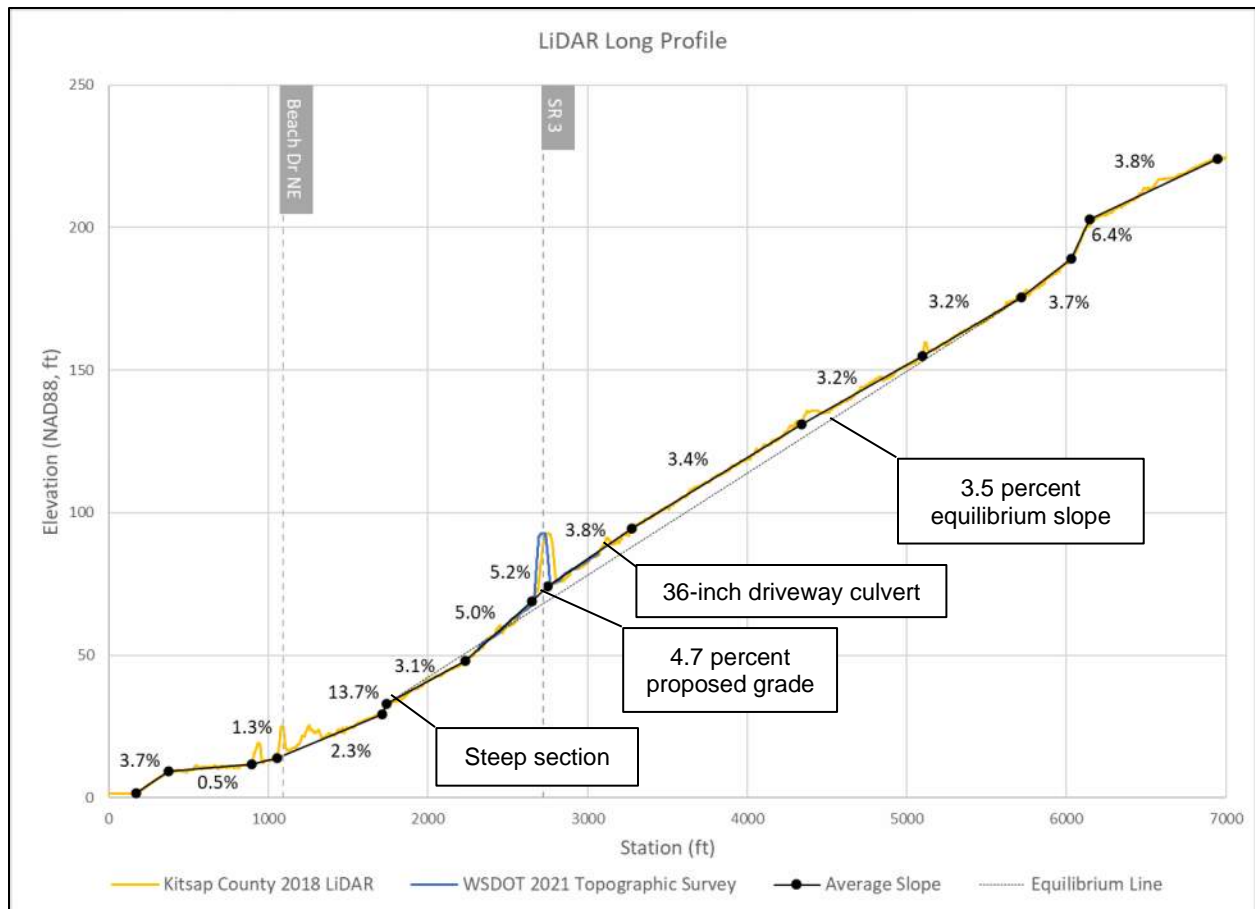
Figure 41. Watershed-scale longitudinal profile

The SR 3 crossing structure is located at a slope transition visibly evident in the LiDAR watershed profile in Figure 41. The long-term average upstream slope is approximately 3.5 percent and has a slightly convex profile shape, likely linked to the glacial till underlying the upper watershed. The downstream reach slope is approximately 4.5 to 5.0 percent, and transitions to a flatter slope before entering Hood Canal. The crossing is located at a change in grade, as well as a change in underlying geology (Section 2.3). As this slope transition creates a concave up-curve in the channel profile, channel aggradation is not considered likely. Approximately 1,000 feet downstream of the crossing the LiDAR indicates there is a short reach with a 13.7-percent slope. This point was not seen during any of the site visits. The cause and long-term stability of this point are unknown.

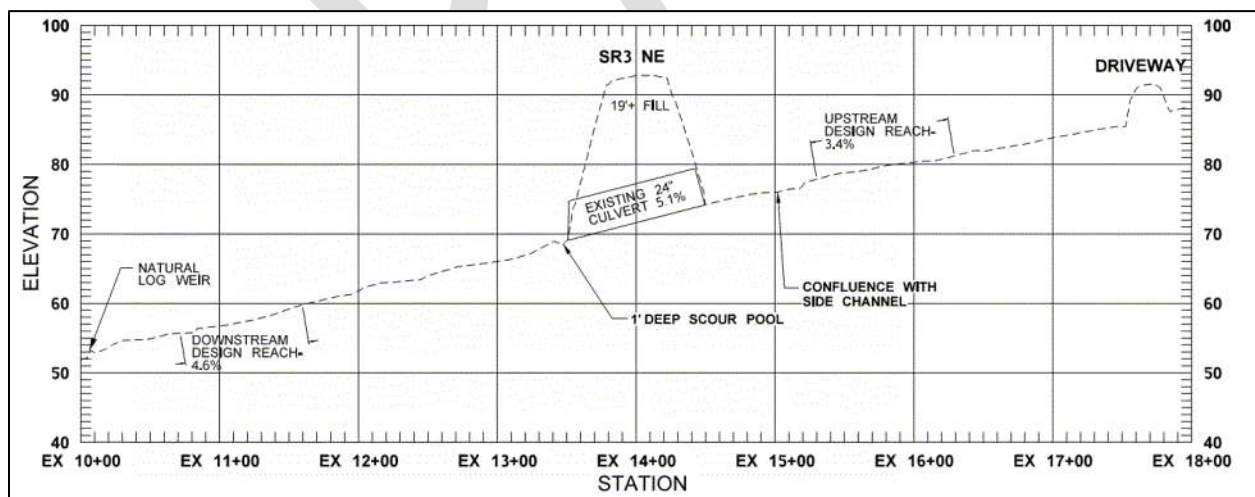
Figure 42. Longitudinal profile from ground survey

The ground survey confirms the LiDAR slopes and maps the slope upstream of the crossing as 3.4 percent and downstream is 4.6 percent (Figure 42). The ground survey shows a gradual steepening across the project site and does not pick up any significant knickpoints or other breaks in the longitudinal slope. A knickpoint is present at approximately STA 60+00. It was not determined whether this is a potential sediment source. The distance from the project crossing make the knickpoint unlikely to affect the proposed structure during its lifespan. The median sediment size was approximately the same between the upstream and downstream reaches, although cobbles and boulders were more common in the downstream reach. The larger boulders observed are likely glacial deposits that are being uncovered and were not transported by the stream. Sediment supply to the crossing is low as a result of the upstream driveway culvert. Therefore, the crossing currently has a low risk of aggregation.

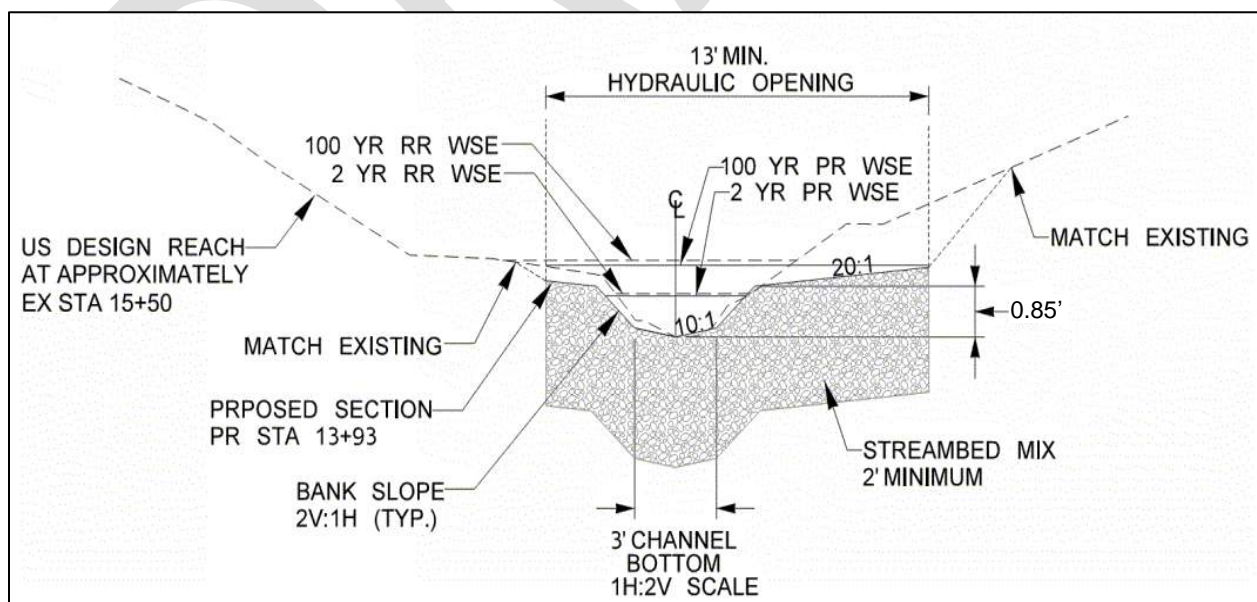
Figure 43. Design cross-section

As noted in Section 2.7.2 some of the observed banks were nearly vertical while others sloped gradually. Accordingly, the proposed channel shape is a balance between matching the existing channel as best as possible given the limitations of uniform synthetic channel design and constructable slopes needing to be a maximum slope of 2H:1V. The channel planform and shape do not fully capture the variability that will result from the natural building material and complexity features discussed in Section 4.3.2. The generalized shape of the proposed channel geometry is a two-stage channel with a relatively flat 3-foot-wide channel bottom, which then slopes up at 2H:1V for 0.7 vertical feet resulting in a 5.8-foot top-of-bank width. The proposed bankfull channel is 0.9 feet deep and 5.8 feet wide, resulting in a width-to-depth ratio of 6.8.

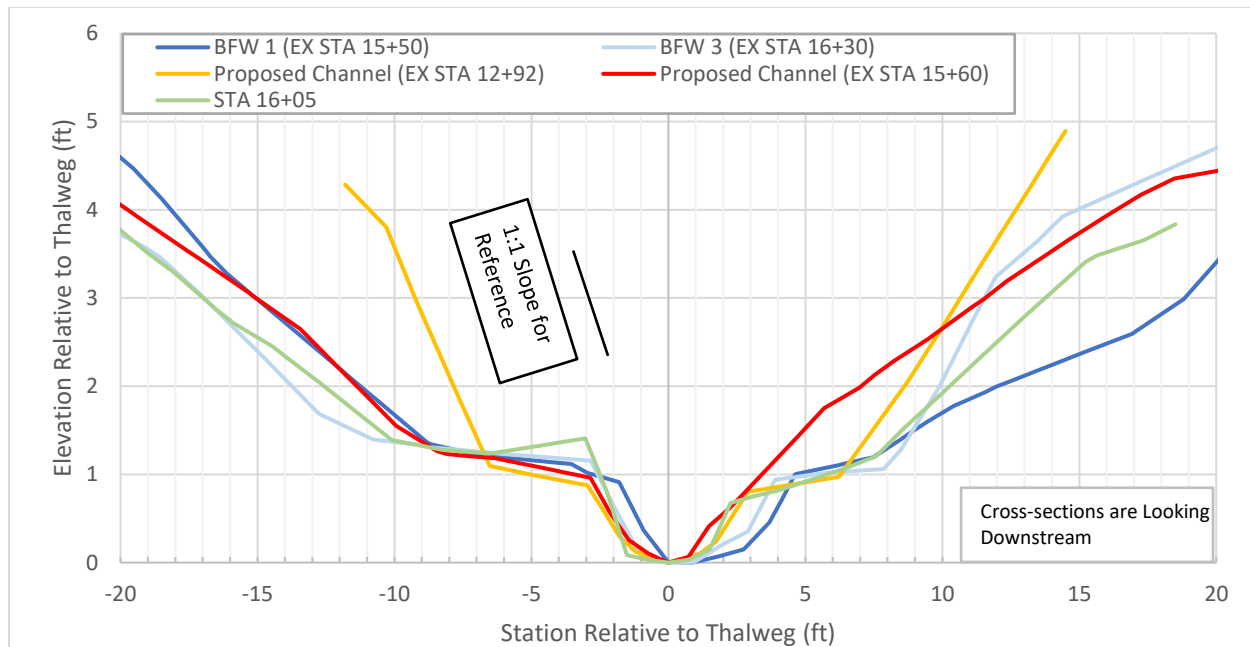
Figure 44. Proposed cross-section superimposed with existing survey cross-sections

The proposed bankfull channel connects to 20H:1V variable width floodplain benches on each side until it reaches the MHO width of 13 feet described in Section 4.2. Figure 44 shows the comparison of the proposed section with all the BFW measurement locations including the downstream ones. In the regraded channel outside the crossing, the edge of the MHO ties into the existing ground at a 2H:1V slope depending on the surrounding terrain. If the 2H:1V slope

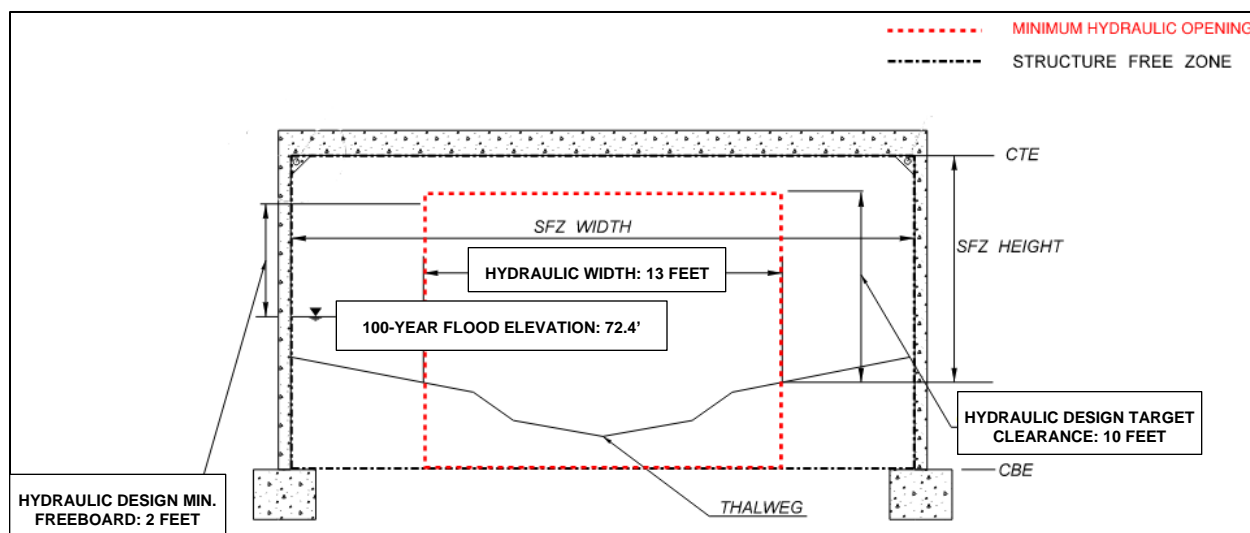
Figure 45. Minimum Hydraulic Opening illustration (Not to scale)

The MHO is defined horizontally by the hydraulic width and the total height is determined by vertical clearance and scour elevation. This section describes the minimum hydraulic width and vertical clearance. For discussion on the scour elevation see Section 7. See Figure 45 for an illustration of the MHO, hydraulic width, freeboard, and maintenance clearance terminology. The Structure-Free Zone (SFZ) is, at a minimum, the same as the MHO.

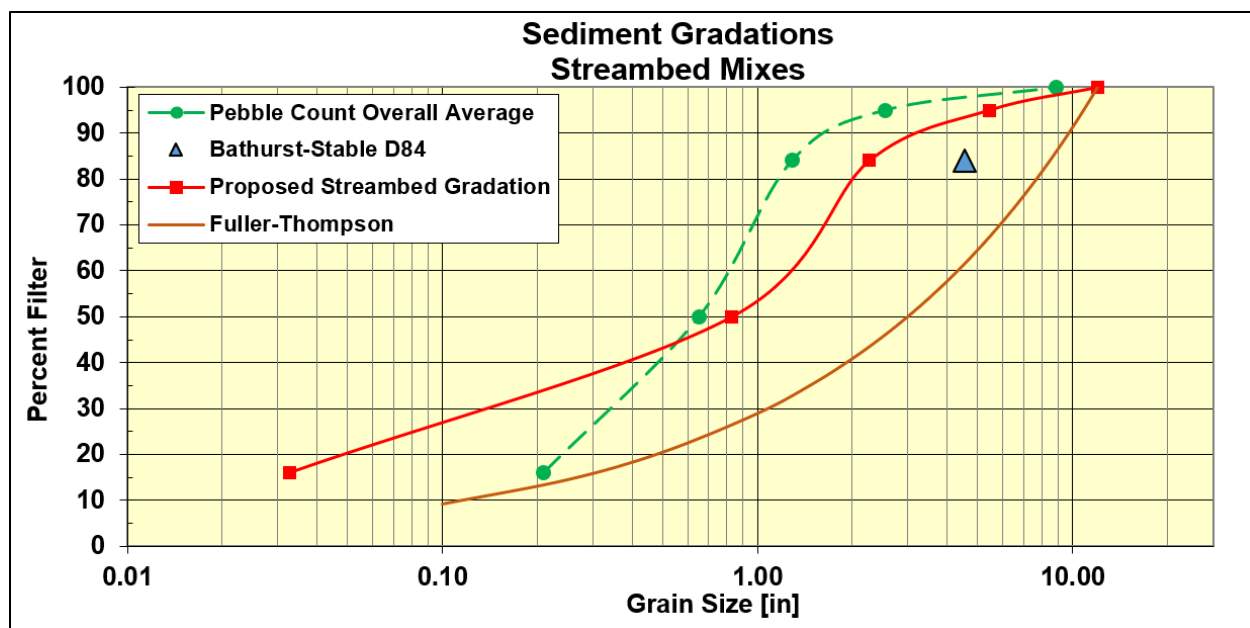
Figure 46. Existing and proposed streambed gradation comparisons

The Bathurst method is applicable for steeper channels where flow depth is more variable due to the presence of large rocks or woody debris that cause flow depth to change rapidly (USFS, 2008). The UNT to Hood Canal is a small stream and, in both the observed and proposed conditions, LWM and boulders create hydraulic depth variability. Therefore, the Bathurst method was considered the most appropriate method for this project. The Bathurst method calculates a stable D₈₄ for a channel based on slope, 100-year flow, and bankfull channel width (Figure 46).

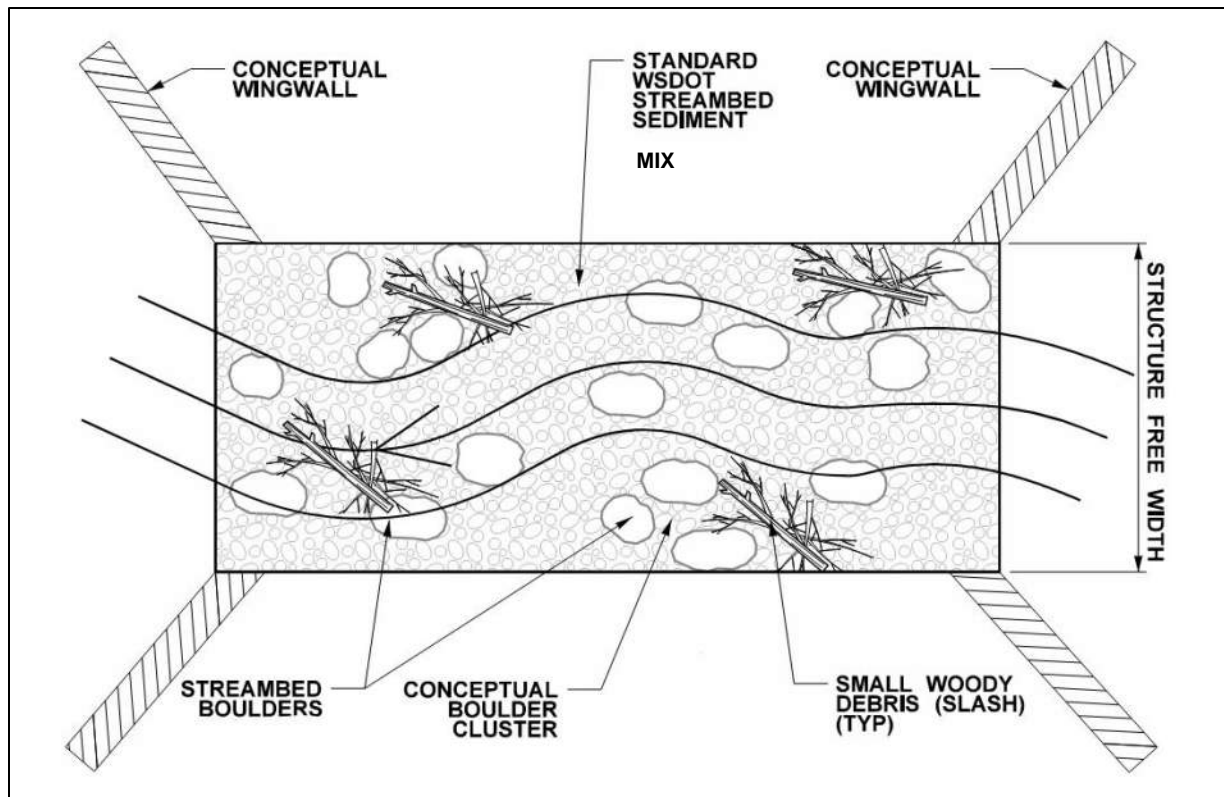
Figure 48. Conceptual layout of crossing complexity features

The boulders are intended to be stable at all flow events. A conceptual layout of banks and crossing complexity features including boulder clusters is shown in shown in Figure 48. The figure is for illustrative purposes only; it is not drawn to scale and should not be considered a construction detail. The layout has most, but not all, of the rougher features along the banks or in the overbank areas. The exact size and density of the features within the structure will be confirmed in the final stage of design.

The second limitation of the model is the shape of the complexity features. The proposed complexity feature shapes are roughly built into the mesh through InRoads template using curves with 52-foot wavelengths. Although the model surface has perfectly uniform sinuous shape as shown in Figure 48, the actual constructed geometry of the channel will be more varied and less symmetrical.

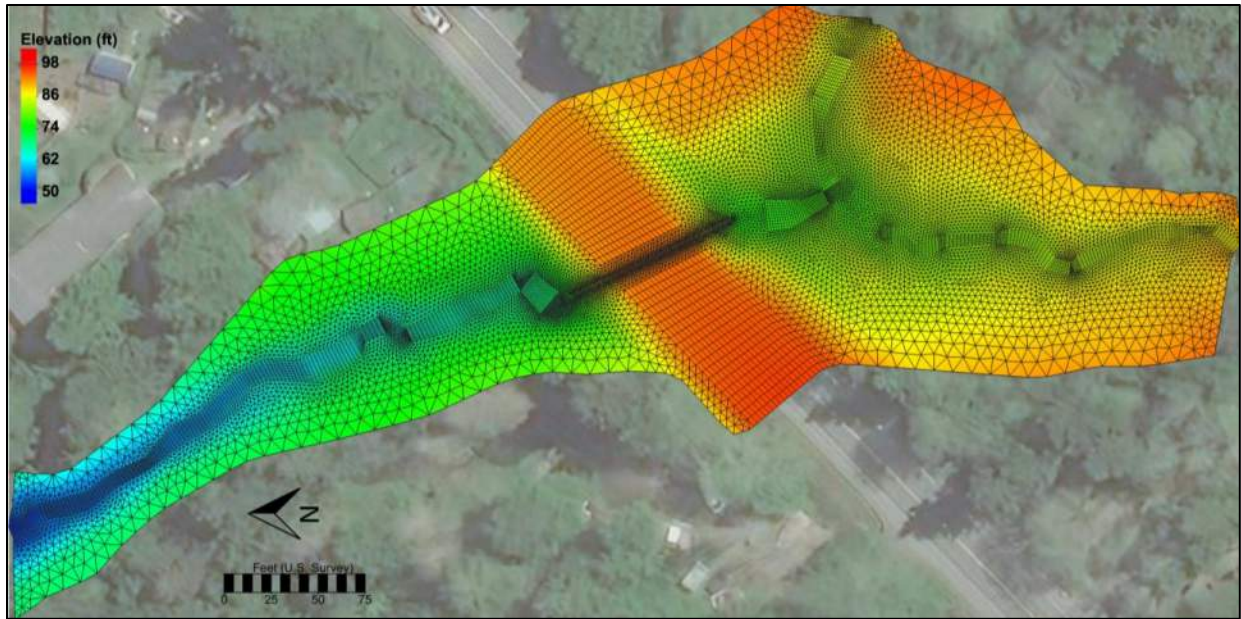
Figure 49. Existing-conditions computational mesh with underlying terrain

The mesh developed for the existing-conditions hydraulic model has an area of 80,736 square feet and contains 23,292 elements (Figure 49). The proposed condition is comprised of the same area and 18,146 elements. The mesh developed for the future-conditions hydraulic model has the existing culvert area replaced with the proposed channel using quadrilateral elements (Figure 50). These quadrilateral elements were also used to represent uniform regions including the existing and proposed channels and the SR 3 roadway surface. Transitions and bends within the existing and proposed stream channel are represented by triangle mesh elements which better capture flow in multiple directions. The floodplain and forested areas are also represented by triangular mesh elements.
